Design Guide

for Improving School Safety
in Earthquakes, Floods, and High Winds

6 Making Schools Safe From High Winds

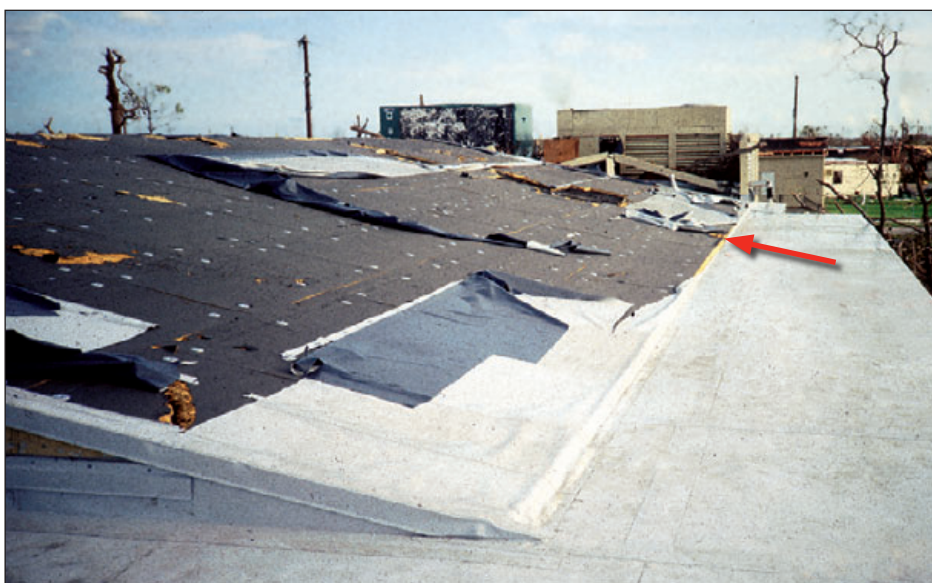
Figure 6-85: This mechanically attached single-ply membrane progressively tore after being cut by wind-borne debris. Hurricane Andrew (Florida, 1992)

Mechanically attached and air-pressure equalized single-ply membrane systems are susceptible to massive progressive failure after missile impact, and are therefore not recommended for schools in hurricane-prone regions. At the school shown in Figure 6-85, a missile struck the fully adhered low-sloped roof and slid into the steep-sloped reinforced mechanically attached single-ply membrane in the vicinity of the red arrow. A large area of the mechanically attached membrane was blown away as a result of progressive membrane tearing. Fully adhered single-ply membranes are very vulnerable to missile puncture and are not recommended unless they are ballasted with pavers.

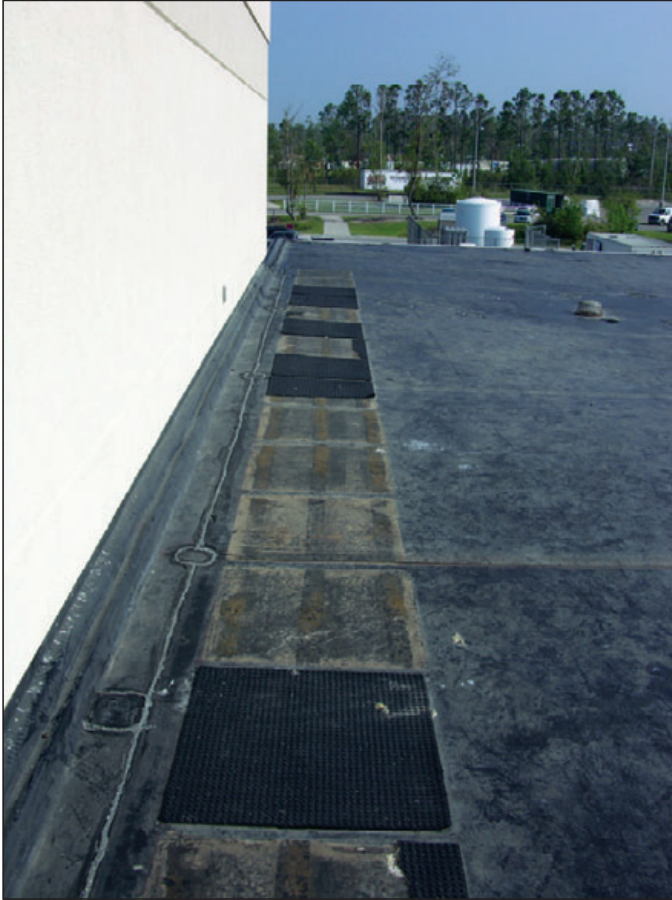
Figure 6-87:
Several rubber walkway pads were blown off the single-ply membrane roof. Estimated wind speed: 130 mph. Hurricane Katrina (Mississippi, 2005)

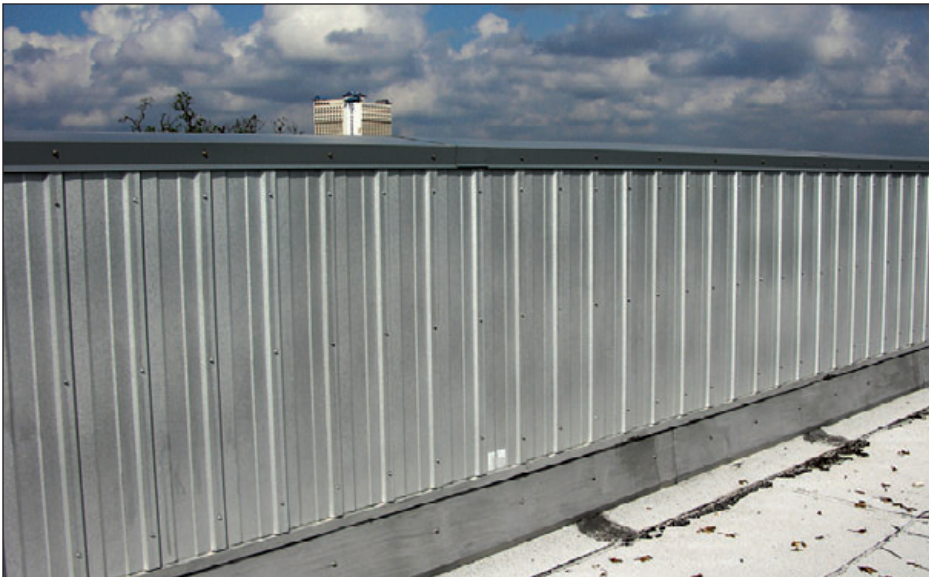
Figure 6-88:
Base flashing protected by metal wall panels attached with exposed screws. Estimated wind speed: 120 mph. Hurricane Katrina (Mississippi, 2005)

- For a PMR, it is recommended that pavers weighing a minimum of 22 psf be specified. In addition, base flashings should be protected with metal (such as shown in Figure 6-88) to provide debris protection. Parapets with a 3-foot minimum height (or higher if so indicated by ANSI/SPRI RP-4) are recommended at roof edges. This manual recommends that PMRs not be used for schools in hurricane-prone regions where the basic wind speed exceeds 175 mph.²⁸
- For structural metal roofs, it is recommended that a roof deck be specified, rather than attaching the panels directly to purlins as is commonly done with pre-engineered metal buildings. If panels blow off buildings without roof decking, wind-borne debris and rain are free to enter the building.

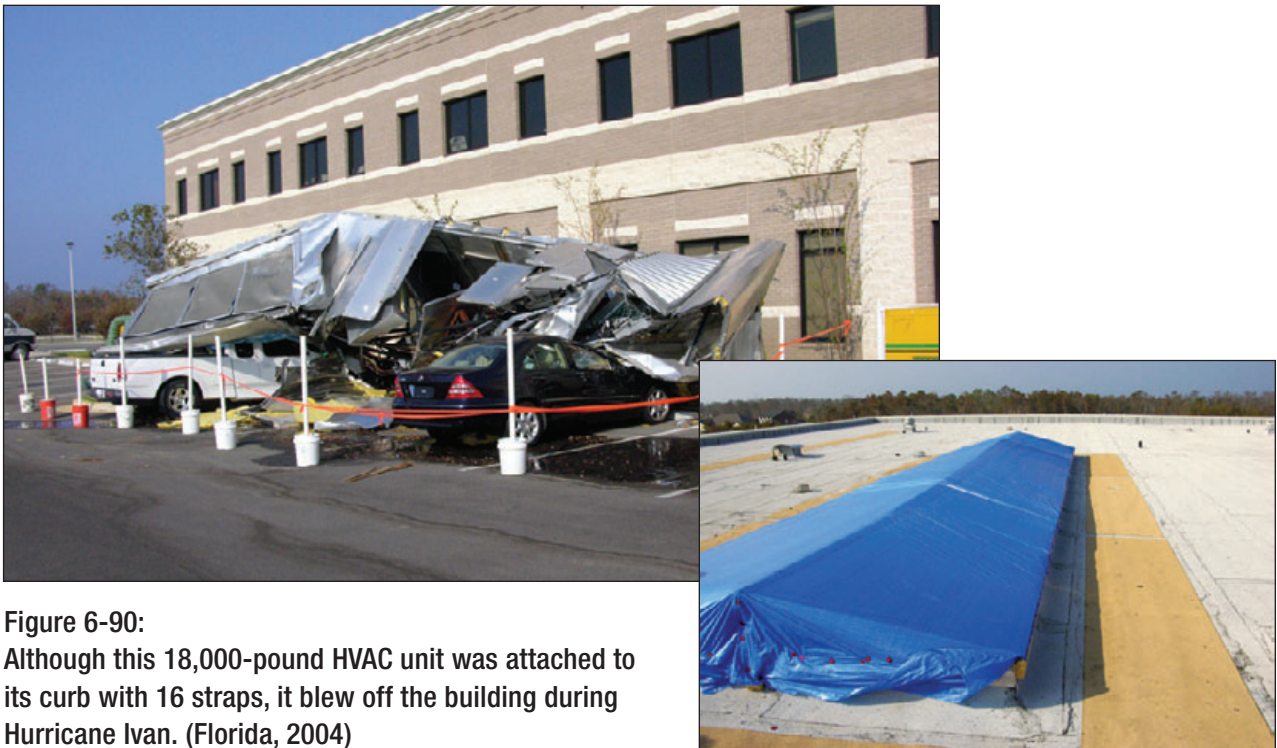
Figure 6-90:
Although this 18,000-pound HVAC unit was attached to its curb with 16 straps, it blew off the building during Hurricane Ivan. (Florida, 2004)

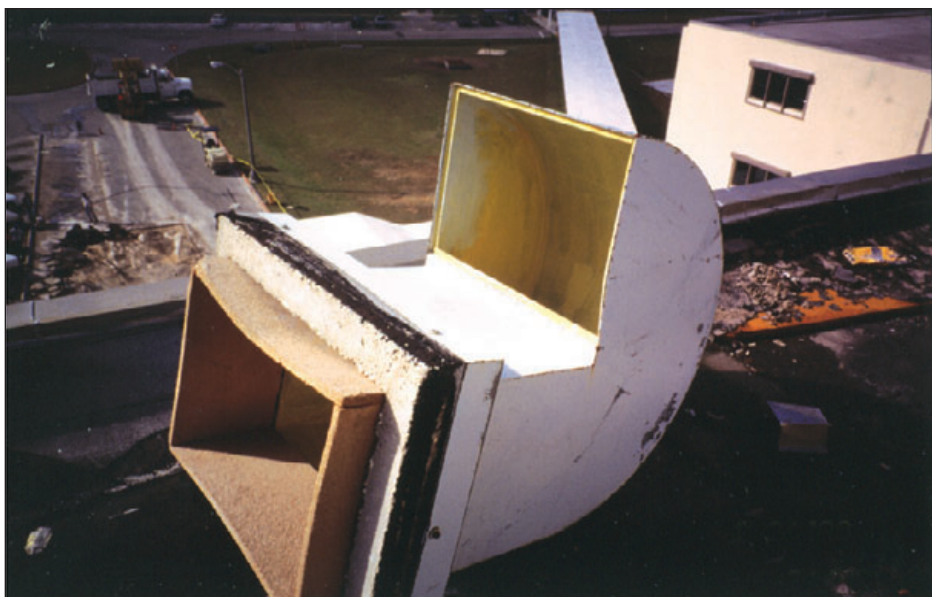
Figure 6-91:
The gooseneck on this building remained attached to the curb, but the curb detached from the deck. Typhoon Paka (Guam, 1997)

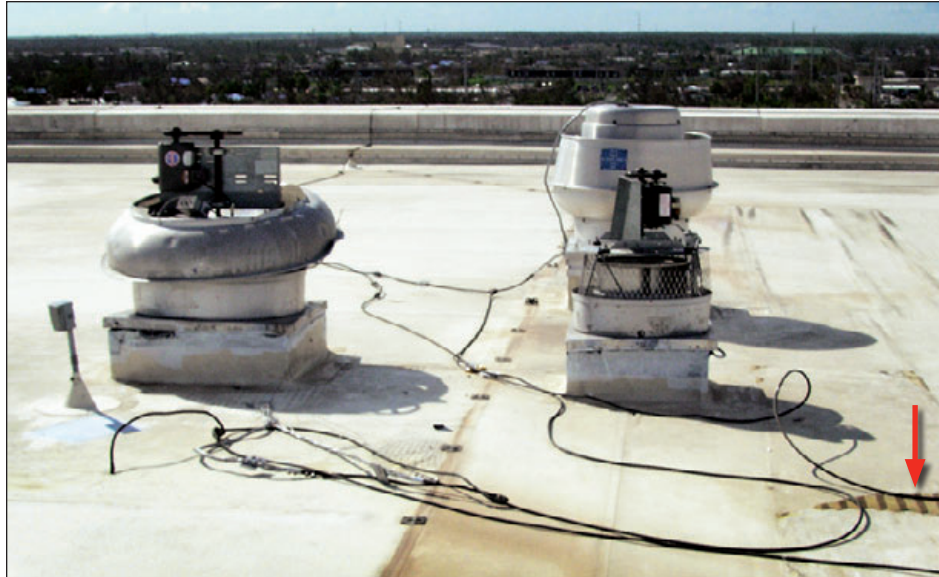
Figure 6-92:
Cowlings blew off
two of the three fans.
Note also the loose
LPS conductors and
missing walkway pad
(red arrow). Estimated
wind speed: 140–160
mph. Hurricane Charley
(Florida, 2004)

Fan cowling attachment: Fans are frequently blown off their curbs because they are poorly attached. When fans are well attached, the cowlings frequently blow off during high winds (see Figure 6-92). Blown-off cowlings can tear roof membranes and break glazing. Unless the fan manufacturer specifically engineered the cowling attachment to resist the design wind load, cable tie-downs (see Figure 6-93) are recommended to avoid cowling blow-off where the basic wind speed is greater than 120 mph.³¹ For fan cowlings less than 4 feet in diameter, $\frac{1}{8}$ -inch diameter stainless steel cables are recommended. For larger cowlings, use $\frac{3}{16}$ -inch diameter cables. When the basic wind speed is 165 mph or less, specify two cables.³² Where the basic wind speed is greater than 165 mph, specify four cables. To minimize leakage potential at the anchor point, it is recommended that the cables be adequately anchored to the equipment curb (rather than anchored to the roof deck). The attachment of the curb itself also needs to be designed and specified.

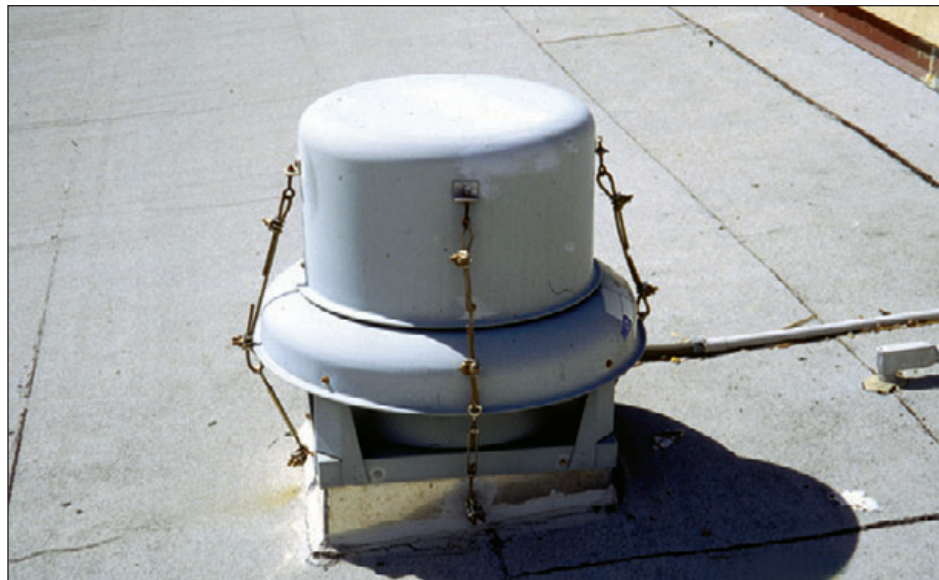
Figure 6-93:
Cables were attached
to prevent the cowling
from blowing off.
Typhoon Paka (Guam,
1997)

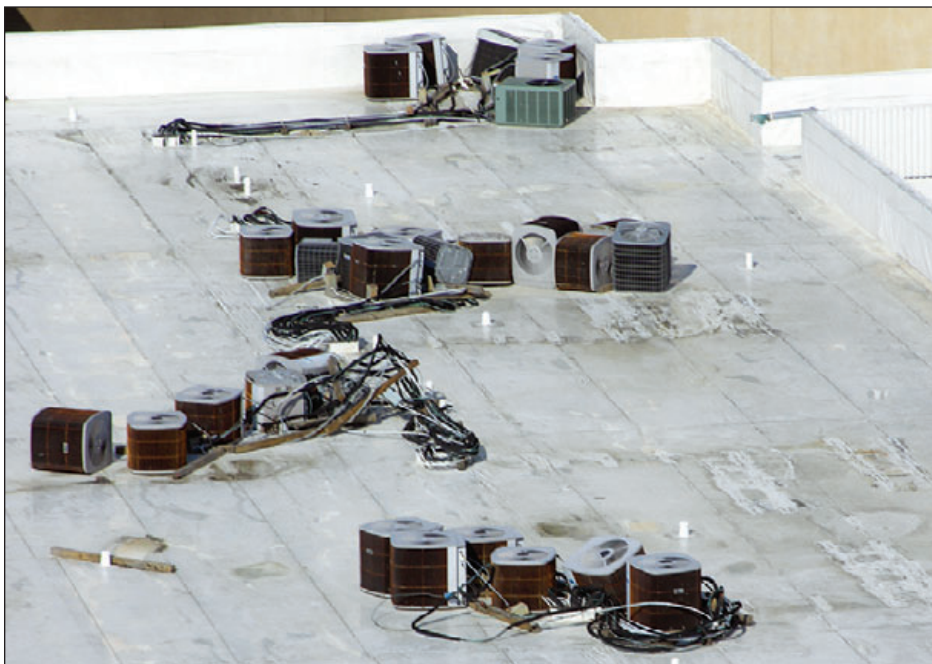
Figure 6-94:
These condensers were blown off their sleepers. Displaced condensers can rupture roof membranes and refrigerant lines. Estimated wind speed: 120 mph. Hurricane Katrina (Mississippi)

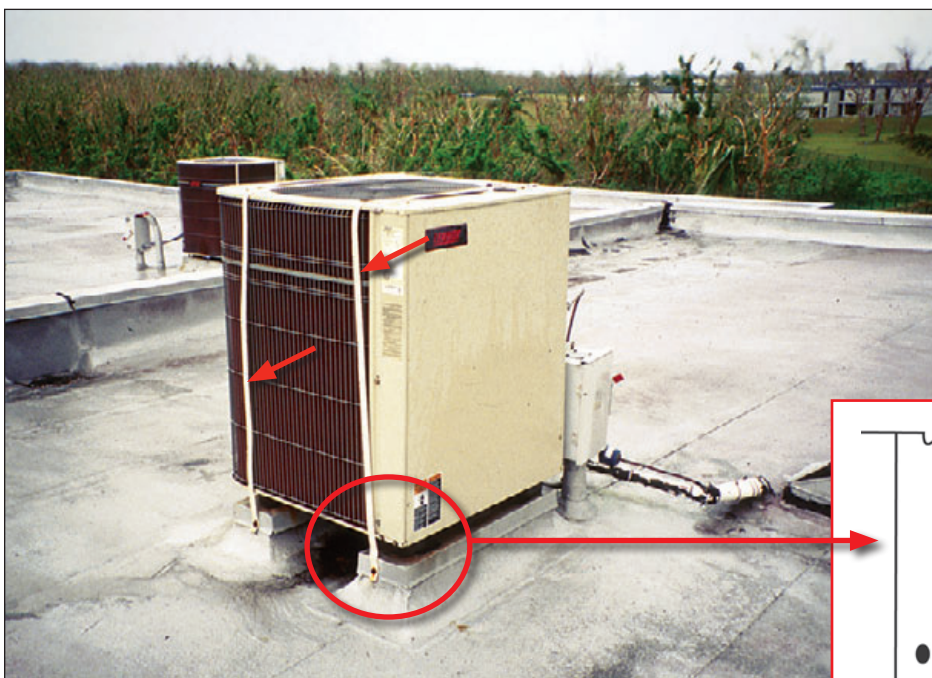
Figure 6-95:
This condenser had supplemental attachment straps (see red arrows). Typhoon Paka (Guam, 1997)

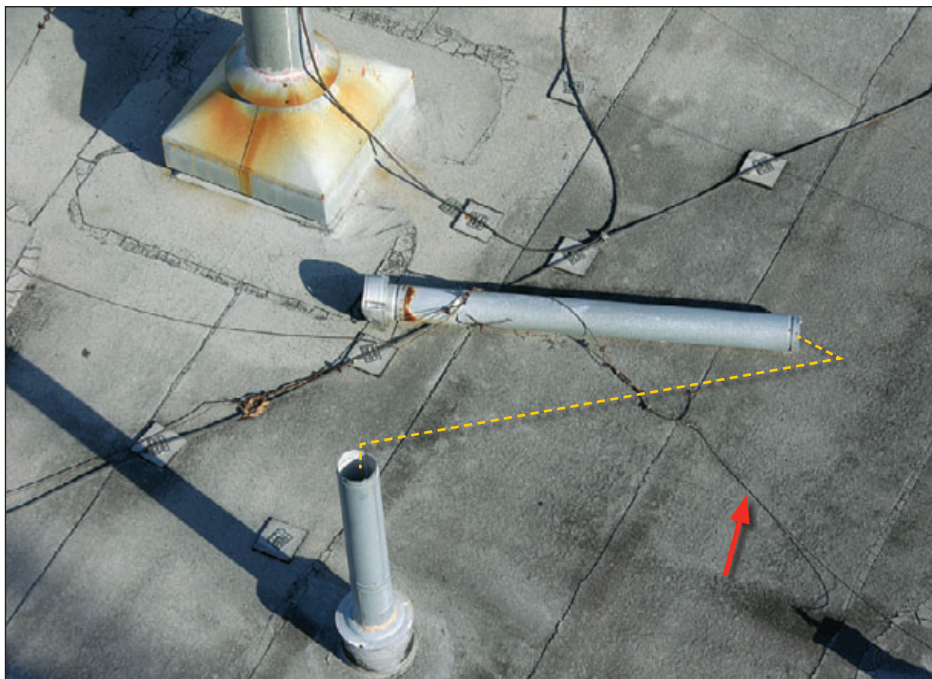
Figure 6-97:
Guyed flue blew over (red arrow indicates one of the guys). Estimated wind speed: 92 mph. Hurricane Ike (Texas, 2008)

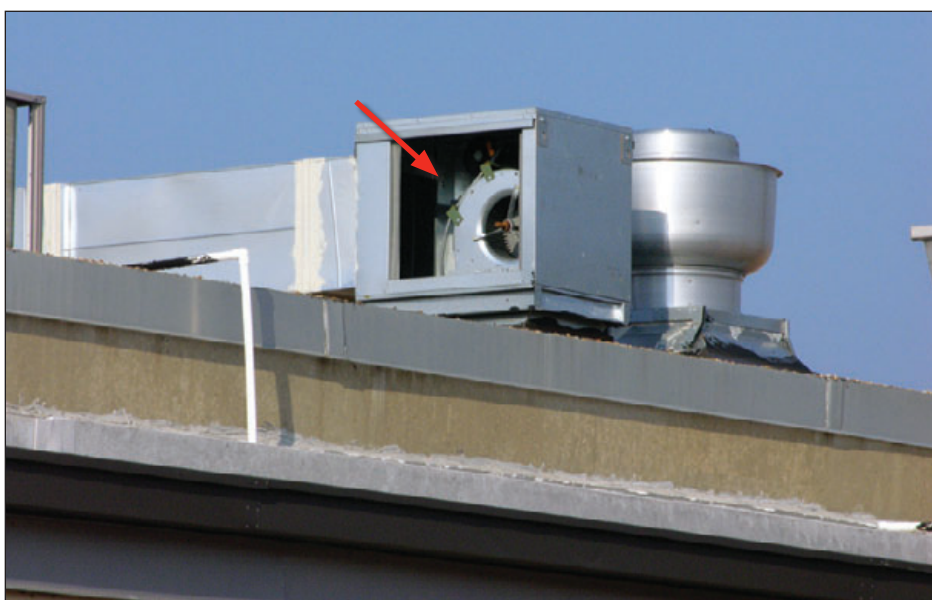
Figure 6-98:
The school shown in Figure 6-65 also had an access panel blow off. Blown-off panels can puncture roof membranes, break glazing, and cause injury. Estimated wind speed: 85–95 mph. Hurricane Ivan (Florida, 2004)

Access panel attachment: Equipment access panels frequently blow off (see Figure 6-98). Unless the equipment manufacturer specifically engineered the panel attachment to resist the design wind load, job-site modifications, such as attaching hasps and locking devices like carabiners, are recommended. The modification details need to be customized. Detailed design may be needed after the equipment has been delivered to the job site. Modification details should be approved by the equipment manufacturer.

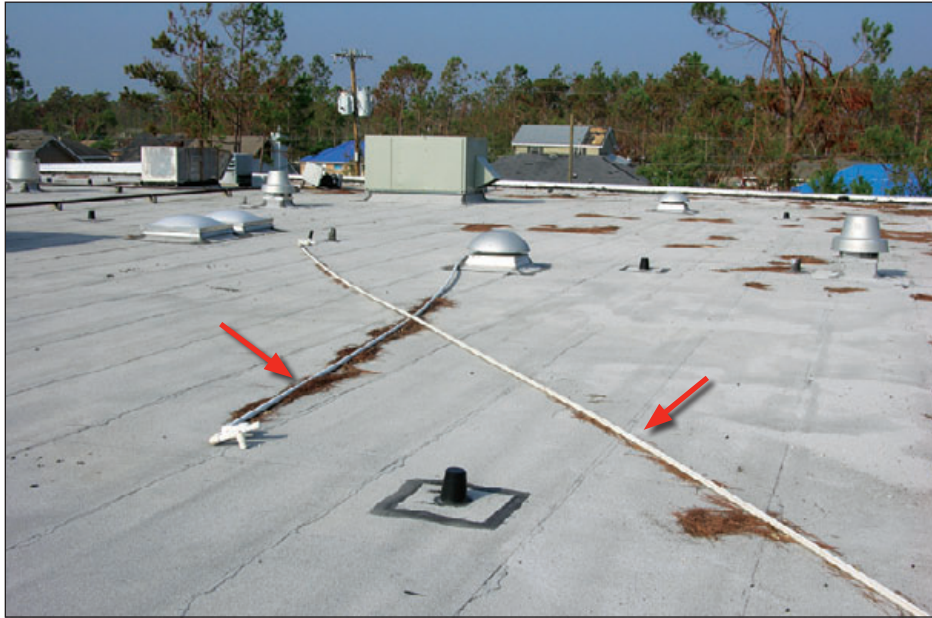
Figure 6-101: These two condensate drain lines detached from their HVAC units. They had not been anchored to the roof. Estimated wind speed: 125 mph. Hurricane Katrina (Mississippi, 2005)

Although blow-off of condensate drain lines is not as potentially catastrophic as rupture of gas lines, blown off condensate drain lines can puncture roof membranes, break glazing, and cause injury (see Figure 6-101). Where the basic wind speed is greater than 120 mph,³⁵ it is recommended that condensate drain line supports be designed and constructed to resist the design wind load.

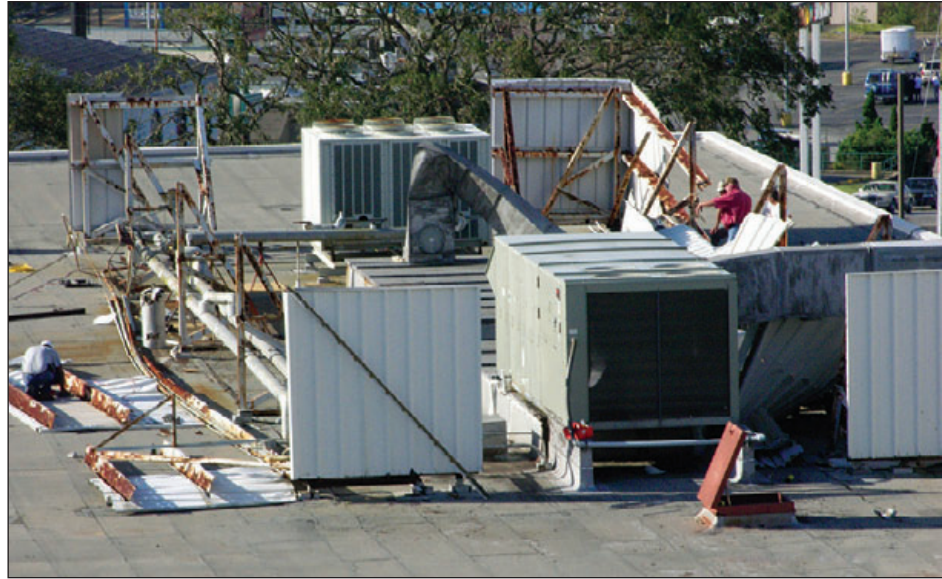
Figure 6-102:
Equipment screen panels can puncture roof membranes, break glazing, and cause injury. Estimated wind speed: 105–115 mph. Hurricane Ivan (Florida, 2004)

Equipment screens: Screens around rooftop equipment are frequently blown away (see Figure 6-102). Screens should be designed to resist the wind load derived from ASCE 7. Since the effect of screens on equipment wind loads is unknown, the equipment attachment behind the screens should be designed to resist the design load.

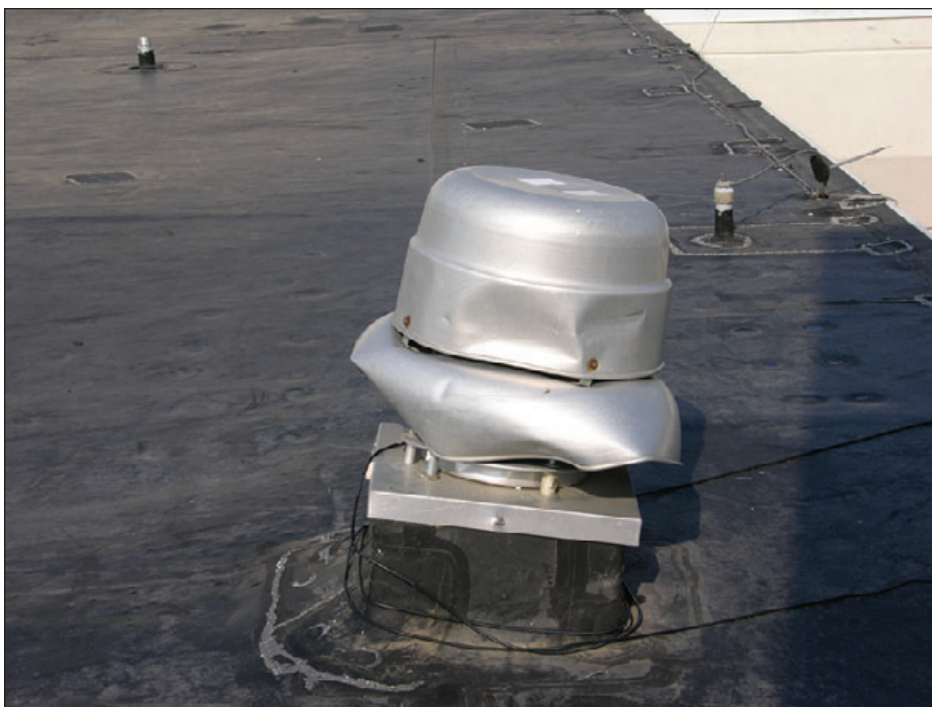
Figure 6-103: This exhaust fan was impacted by wind-borne debris. Although it is often impractical to place all equipment such as fans in penthouses, doing so to the extent possible avoids debris damage. Estimated wind speed: 130 mph. Hurricane Katrina (Mississippi, 2005)

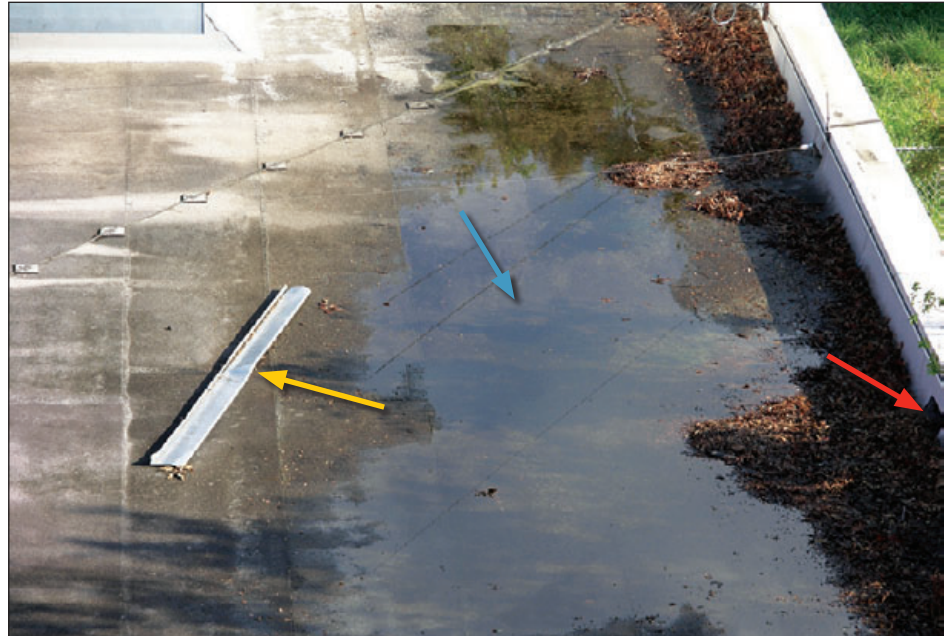
Figure 6-104:
Leaf debris and ponding near a scupper (red and blue arrows). The yellow arrow indicates a piece of coping that blew off an upper roof shown in Figure 6-72. Estimated wind speed: 92 mph. Hurricane Ike (Texas, 2008)

Roof drainage: Roof drains and scuppers have the potential to be blocked by leaves, tree limbs, and other wind-borne debris during a hurricane (see Figure 6-104). If primary and overflow drains/scuppers become blocked, development of deep ponding water may inundate base flashings and cause leakage problems or lead to roof collapse. To avoid problems with blocked drains and scuppers, the following are recommended:

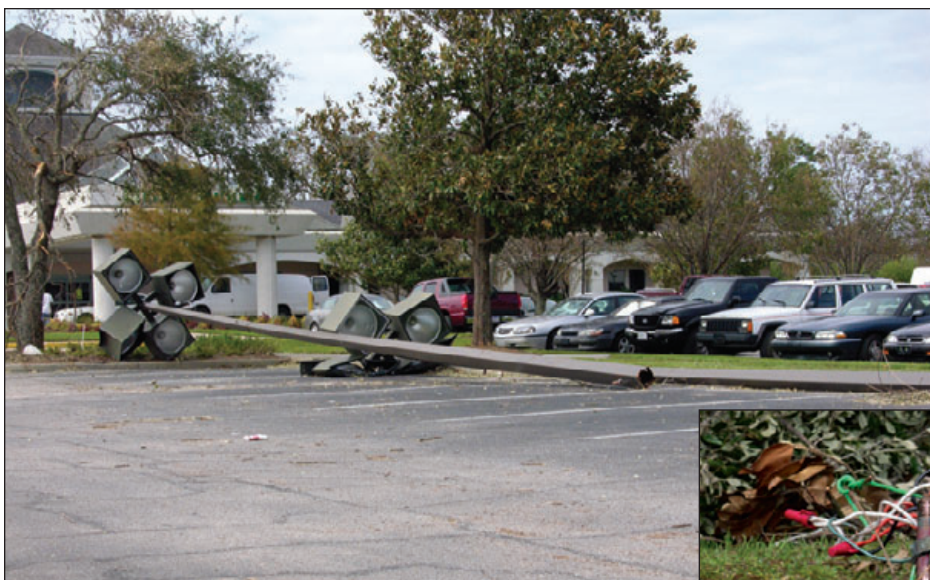
Figure 6-105:
Collapsed light fixtures
caused by severe
corrosion (see inset).
Estimated wind
speed: 105–115 mph.
Hurricane Ivan (Florida,
2004)

To avoid corrosion-induced failure (Figure 6-105), it is recommended that exterior-mounted mechanical, electrical, and communications equipment be made of nonferrous metals, stainless steel, or steel with minimum G-90 hot-dip galvanized coating for the equipment body, stands, anchors, and fasteners. When equipment with enhanced corrosion protection is not available, the designer should advise the building owner that periodic equipment maintenance and inspection is particularly important to avoid advanced corrosion and subsequent equipment damage during a windstorm.

Damage to exterior-mounted electrical equipment is infrequent, mostly because of its small size (e.g., disconnect switches). Exceptions include communication towers, surveillance cameras, electrical service masts, satellite dishes, and LPSs. The damage is typically caused by inadequate mounting as a result of failure to perform wind load calculations and anchorage design. Damage is also sometimes caused by corrosion (see Figure 6-105 and text box in Section 6.3.4.1 regarding corrosion).

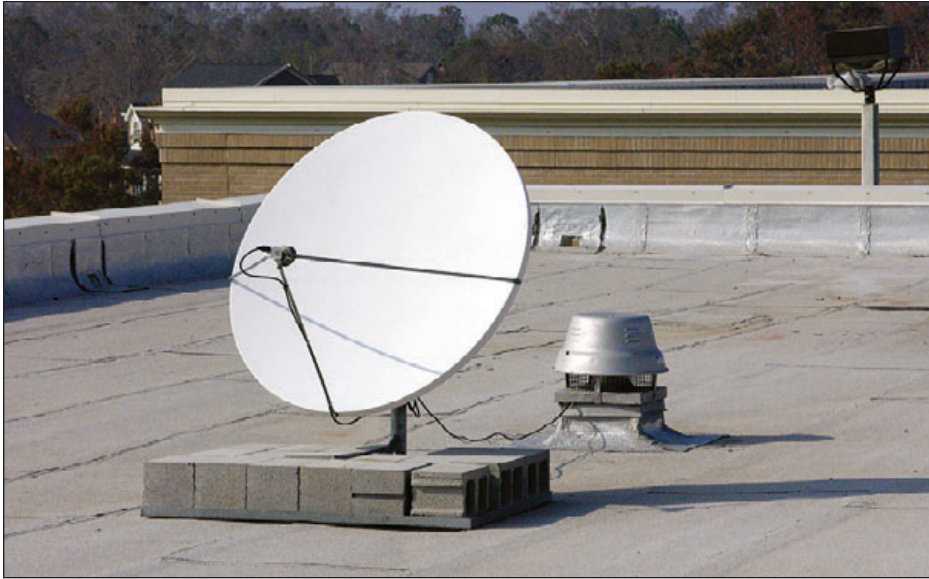
Figure 6-107: Common anchoring method for satellite dish. Estimated wind speed: 85–95 mph. Hurricane Ivan (Florida, 2004)

Satellite dishes: For the satellite dish shown in Figure 6-107, the dish mast was anchored to a large metal pan that rested on the roof membrane. CMU was placed on the pan to provide overturning resistance. This anchorage method should only be used where calculations demonstrate that it provides sufficient resistance. In this case, the wind approached the satellite dish in such a way that it experienced very little wind pressure. In hurricane-prone regions, use of this anchorage method is not recommended (see Figure 6-108).

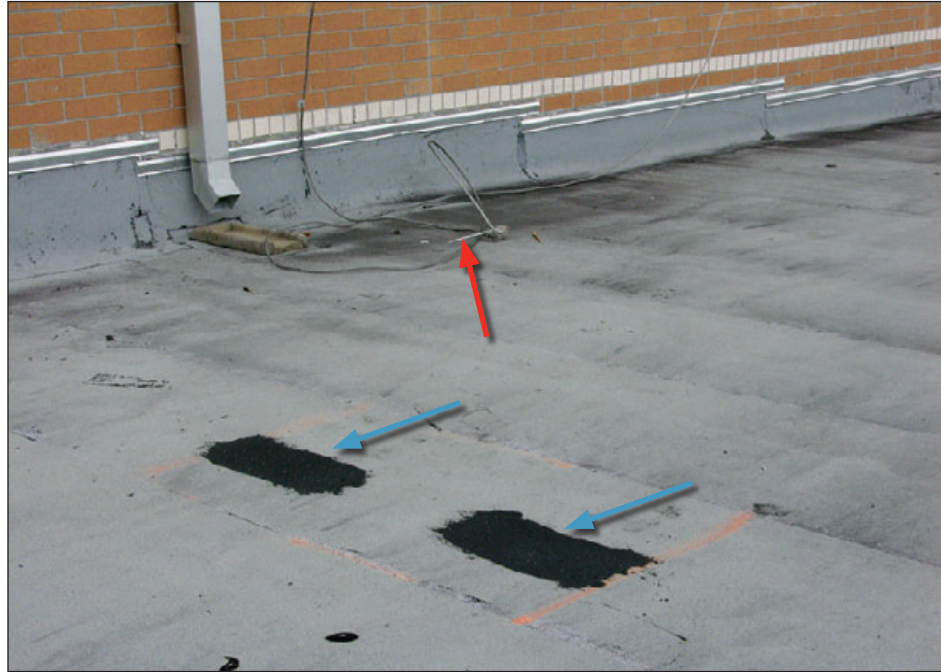
Figure 6-110:
View of an end of a conductor that became disconnected. Estimated wind speed: 130 mph. Hurricane Katrina (Mississippi, 2005)

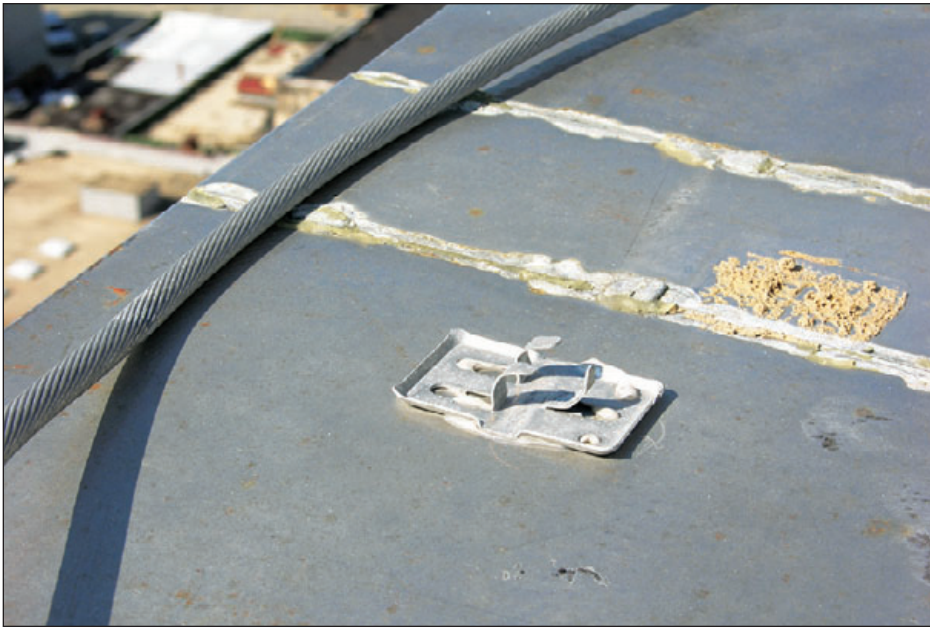
Figure 6-111: This conductor connector was adhered to the coping. The conductor deformed the connector prongs under wind pressure, and pulled away from the connector. Estimated wind speed: 130 mph. Hurricane Katrina (Mississippi, 2005)

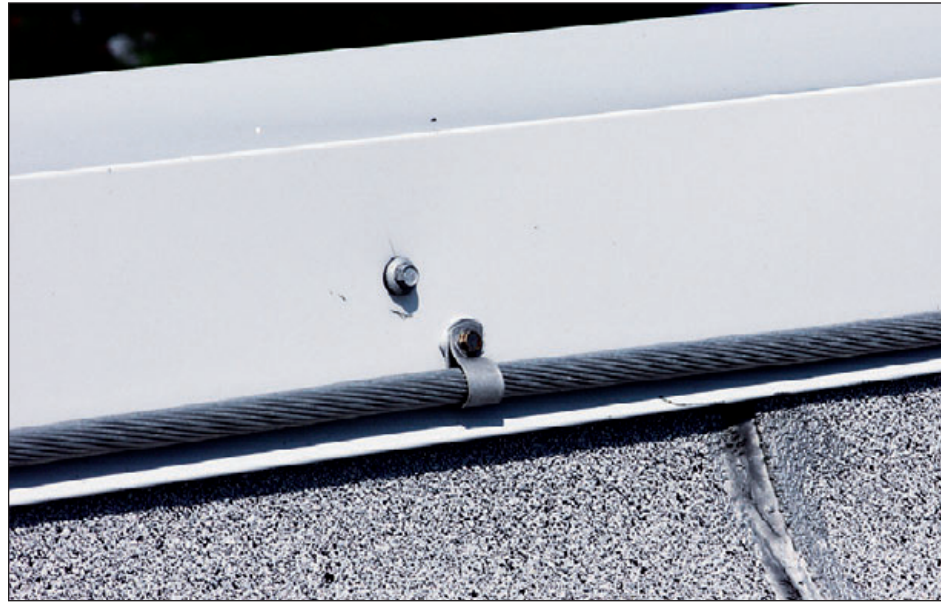
Figure 6-112:
This conductor was
attached to the
coping with a looped
connector. Estimated
wind speed: 130 mph.
Hurricane Katrina
(Mississippi, 2005)

Parapet attachment: When the parapet is 12 inches high or greater, it is recommended that the air terminal base plates and conductor connectors be mechanically attached with #12 screws that have minimum 1¼-inch embedment into the inside face of the parapet nailer and be properly sealed for watertight protection. Instead of conductor connectors that have prongs, it is recommended that mechanically attached looped connectors be installed (see Figure 6-112).

Standing seam metal roofs: It is recommended that pre-manufactured, mechanically attached clips that are commonly used to attach various items to roof panels be used. After anchoring the clips to the panel ribs, the air terminal base plates and conductor connectors are anchored to the panel clips. In lieu of conductor connectors that have prongs, it is recommended that mechanically attached looped connectors be installed (see Figure 6-112).

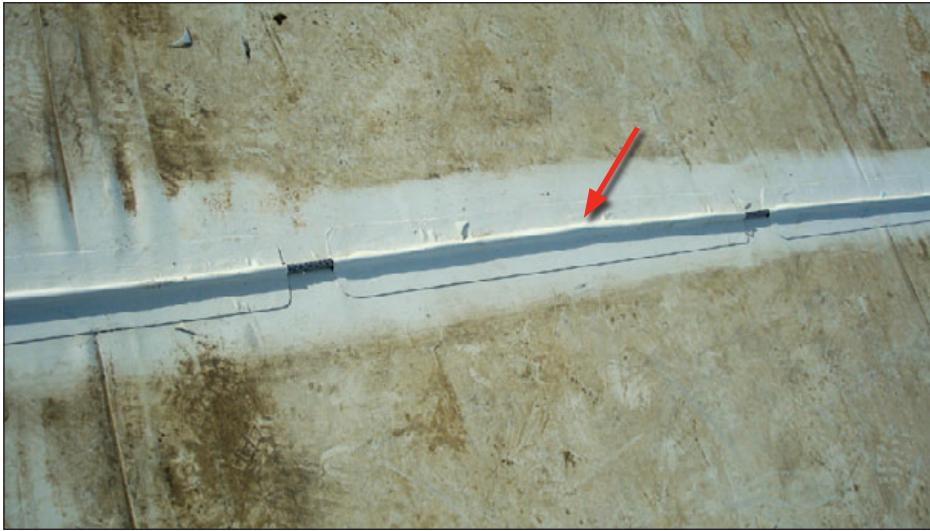
Figure 6-114:
Use of intermittent
membrane flashing
strips to secure an LPS
conductor, as illustrated
in Figure 6-113

In lieu of attaching conductors with conductor connectors, it is recommended that conductors be attached with strips of membrane installed by the roofing contractor. For built-up and modified bitumen membranes, use strips of modified bitumen cap sheet, approximately 9 inches wide at a minimum. If strips are torch-applied, avoid overheating the conductors. For single-ply membranes, use self-adhering flashing strips, approximately 9 inches wide at a minimum. Start the strips approximately 3 inches from either side of the air terminal base plates. Use strips that are approximately 3 feet long, separated by a gap of approximately 3 inches (see Figures 6-113 and 6-114).

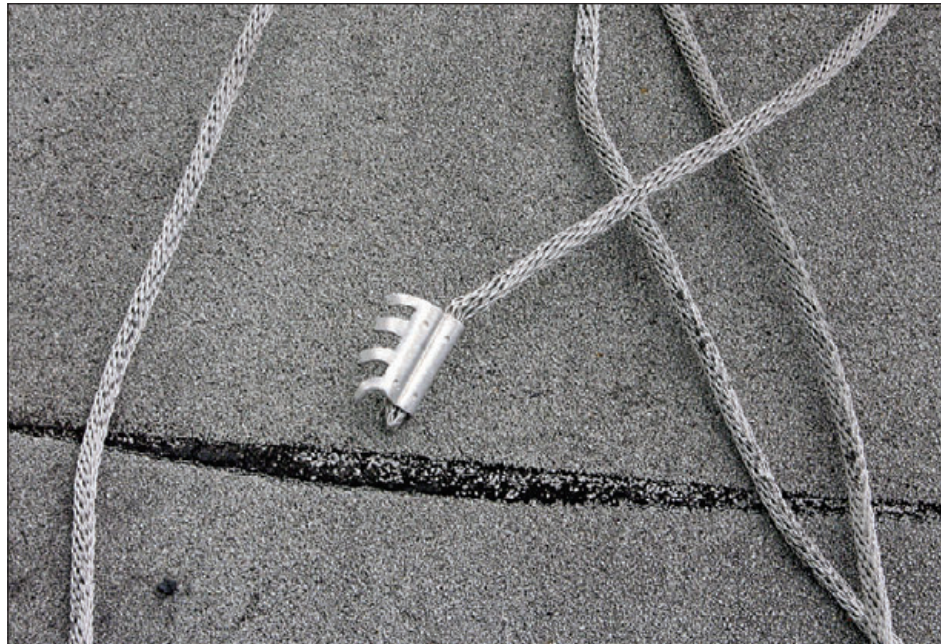
Figure 6-116:
If conductors detach from the roof, they are likely to pull out from pronged splice connectors. Estimated wind speed: 90–100 mph. Hurricane Charley (Florida, 2004)

Conductor splice connectors: In lieu of pronged splice connectors (see Figure 6-116), bolted splice connectors are recommended because they provide a more reliable connection (see Figure 6-117). It is recommended that strips of flashing membrane (as recommended above) be placed approximately 3 inches from either side of the splice connector to minimize conductor movement and to avoid the possibility of the conductors becoming disconnected. To allow for observation during maintenance inspections, do not cover the connectors.

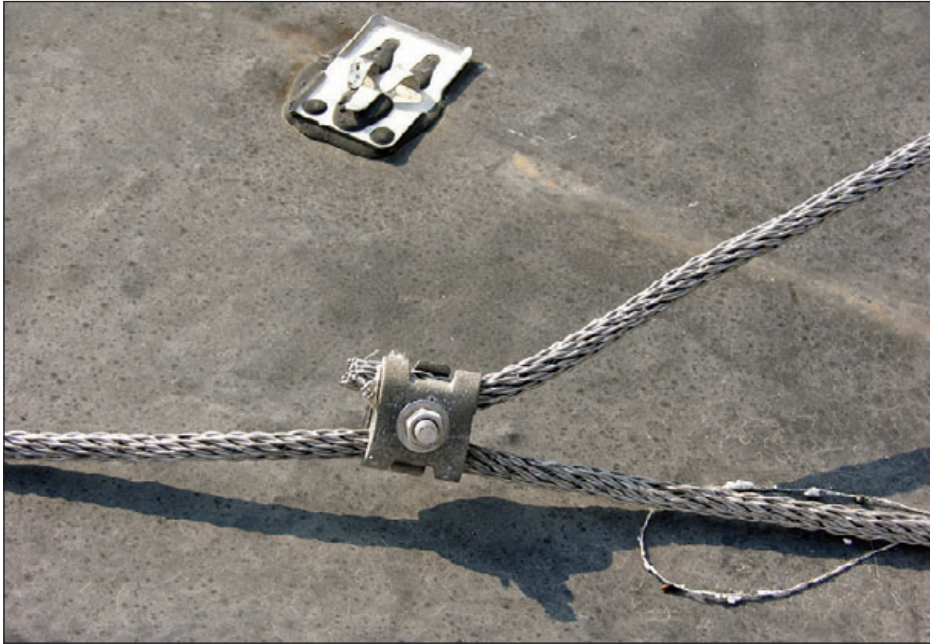
Figure 6-117: Bolted splice connectors are recommended to prevent free ends of connectors from being whipped around by wind. Estimated wind speed: 130 mph. Hurricane Katrina (Mississippi, 2005)

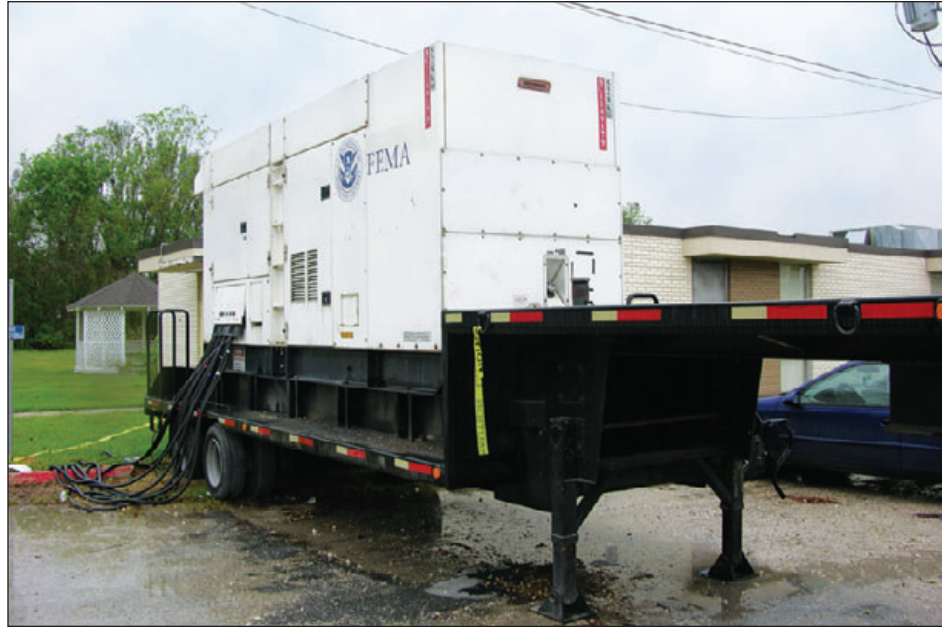
Figure 6-118:
In lieu of permanent on-site emergency generators, portable generators can be an economical way to provide electrical power to schools used as hurricane recovery centers. Estimated wind speed: 108 mph. Hurricane Ike (Texas, 2008)

For schools that will be used as recovery centers after a hurricane, it is recommended that the schools be equipped with an emergency generator or have pre-hurricane arrangements for delivery of a portable generator to the school prior to the recovery center becoming operational (see Figure 6-118). (Note: It could take a few or several days for a portable generator to be delivered.) If a portable generator rather than a permanent

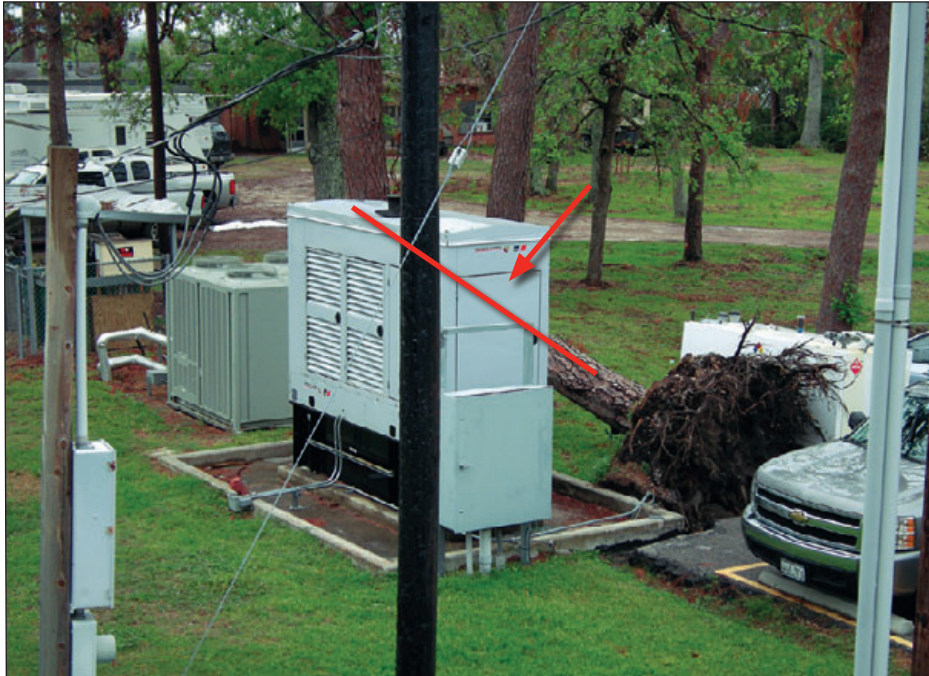
Figure 6-119:
The tree shown by the red line nearly fell on the emergency generator (red arrow). Estimated wind speed: 110 mph. Hurricane Ike (Texas, 2008)

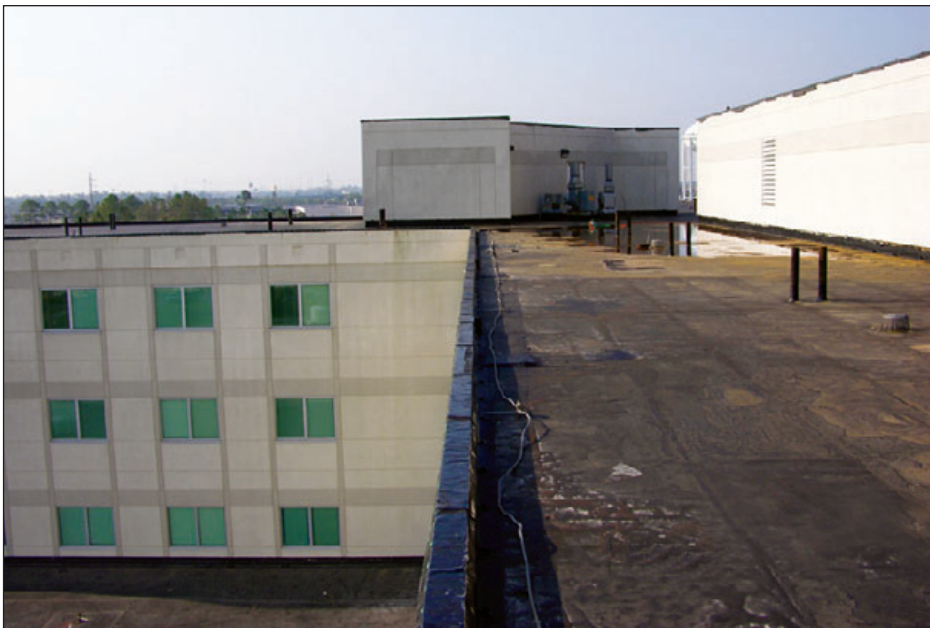
Figure 6-120:
The roof and a portion of the EIFS on this 5-year-old building blew off. Water leaked into the floor below. The floor was taken out of service for more than a month. Estimated wind speed: 130 mph. Hurricane Katrina (Mississippi, 2005)

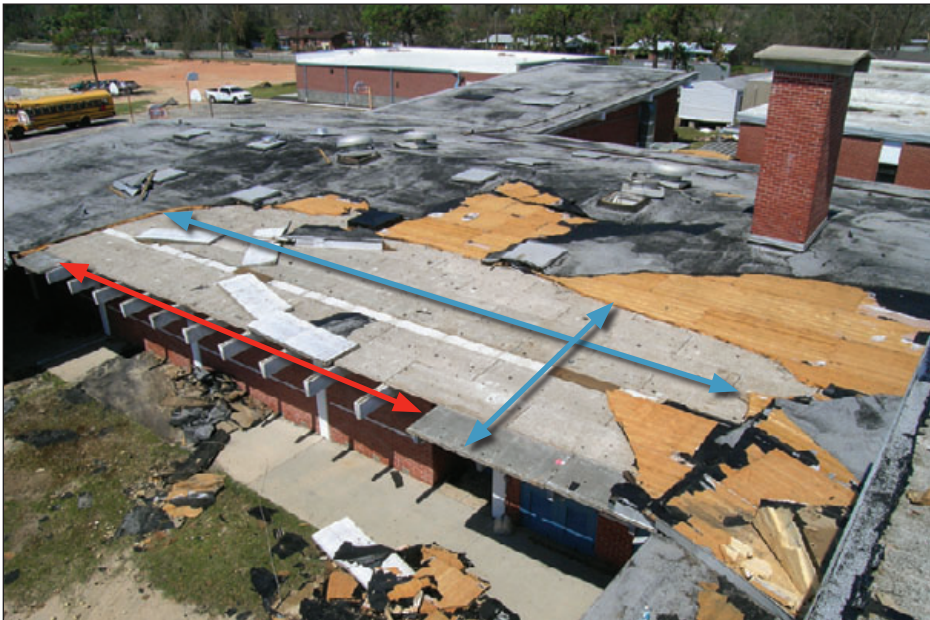
Figure 6-121
The cementitious wood-fiber deck panels blew off of much of the overhang at this school. Deck panel failure resulted in lifting and peeling of the roof system over a large area, exposure of the decking in the area shown by the blue arrows, and extensive interior water infiltration. Estimated wind speed: 105–115 mph. Hurricane Ivan (Florida, 2004)

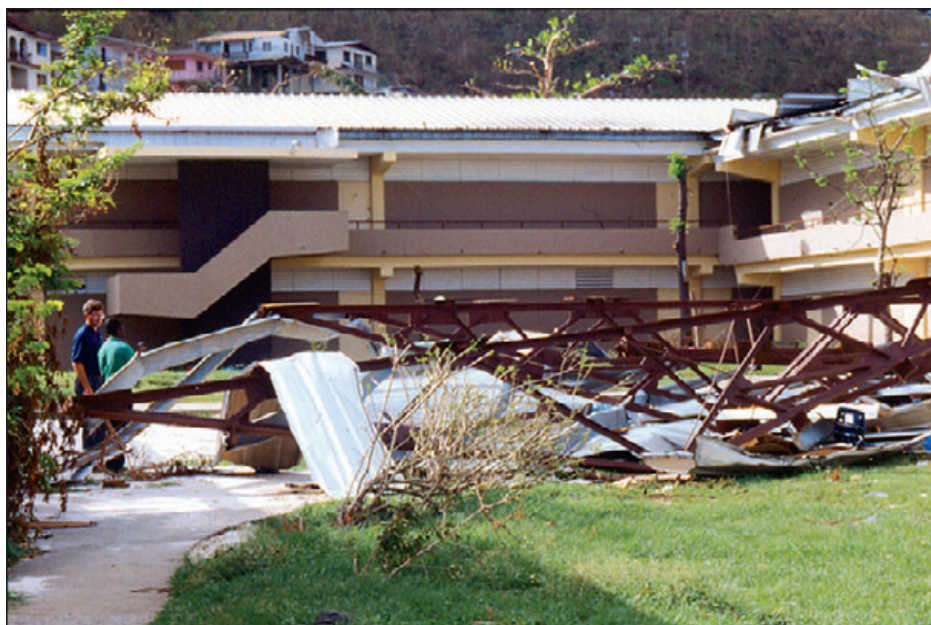
Figure 6-122:
The steel truss superstructure installed on this school as part of a steep-slope conversion blew away because of inadequate attachment. Hurricane Marilyn (U.S. Virgin Islands, 1995)

If a low-slope roof is converted to a steep-slope roof, the new support structure should be engineered and constructed to resist the wind loads and avoid the kind of damage shown in Figure 6-122.

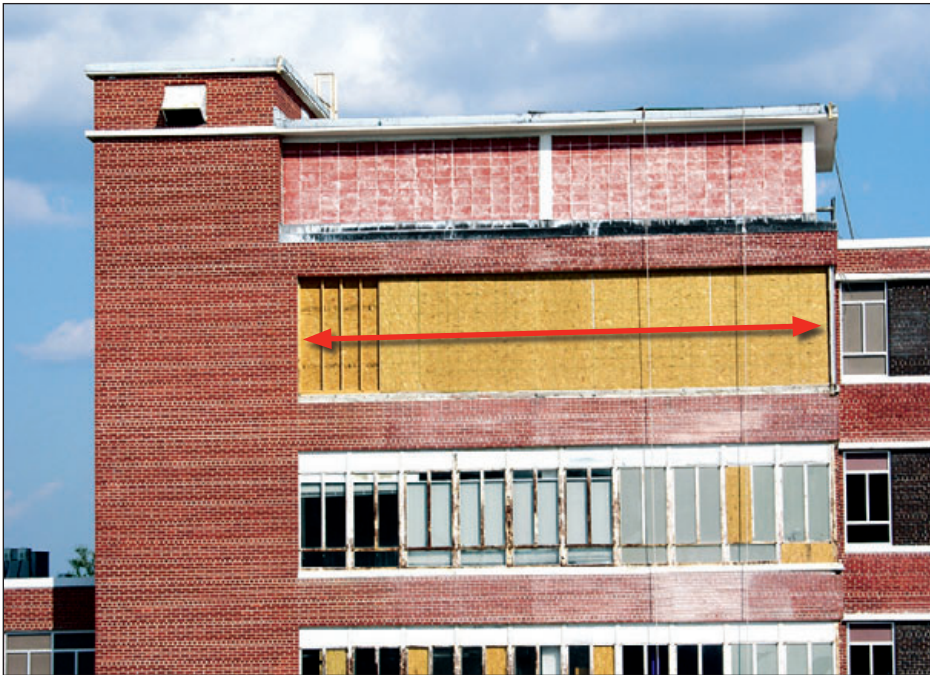
Figure 6-123:
Wind pressure caused the window frames on the upper floors to fail (red arrow). Estimated wind speed: 130 mph. Hurricane Katrina (Mississippi, 2005)

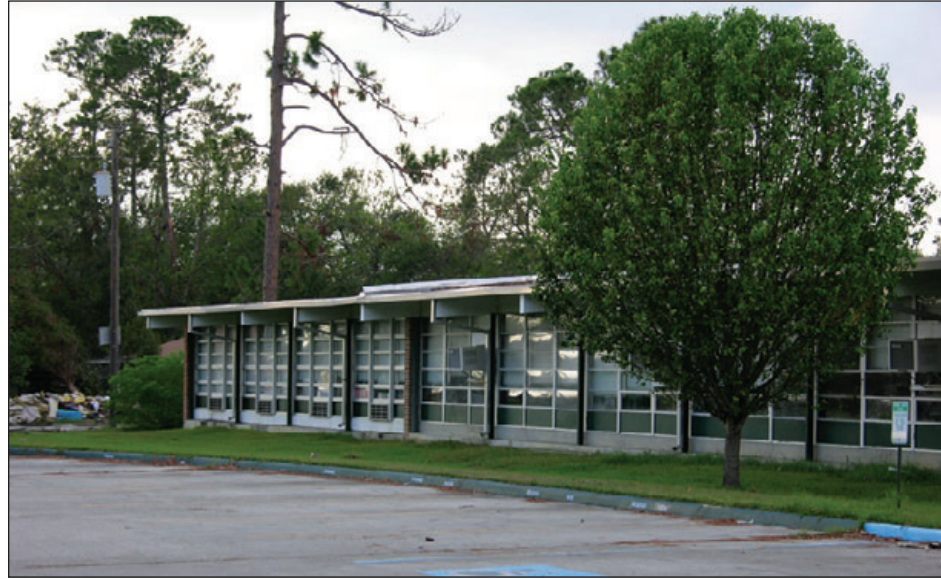
Figure 6-124:
On-site water-spray testing in accordance with ASTM E 1105 can be used to evaluate wind-driven rain resistance. Older window assemblies such as the ones at this school are often quite susceptible to leakage. Estimated wind speed: 125 mph. Hurricane Katrina (Mississippi, 2005)

Some older window assemblies have sufficient strength to resist the design pressure, but are inadequate to resist wind-driven rain. If the lack of water resistance is due to worn glazing gaskets or sealants, replacing the gaskets or sealant may be viable. In other situations, replacing the existing assemblies with new, higher-performance assemblies may be necessary. On-site testing in accordance with ASTM E 1105 can be used to evaluate wind-driven rain resistance of suspect windows (see Figure 6-124). (Note: Shutters placed over windows to provide wind-borne debris protection should not be relied upon to protect against wind-driven rain. If existing windows are susceptible to debris and leakage, the windows should be replaced with new assemblies.)

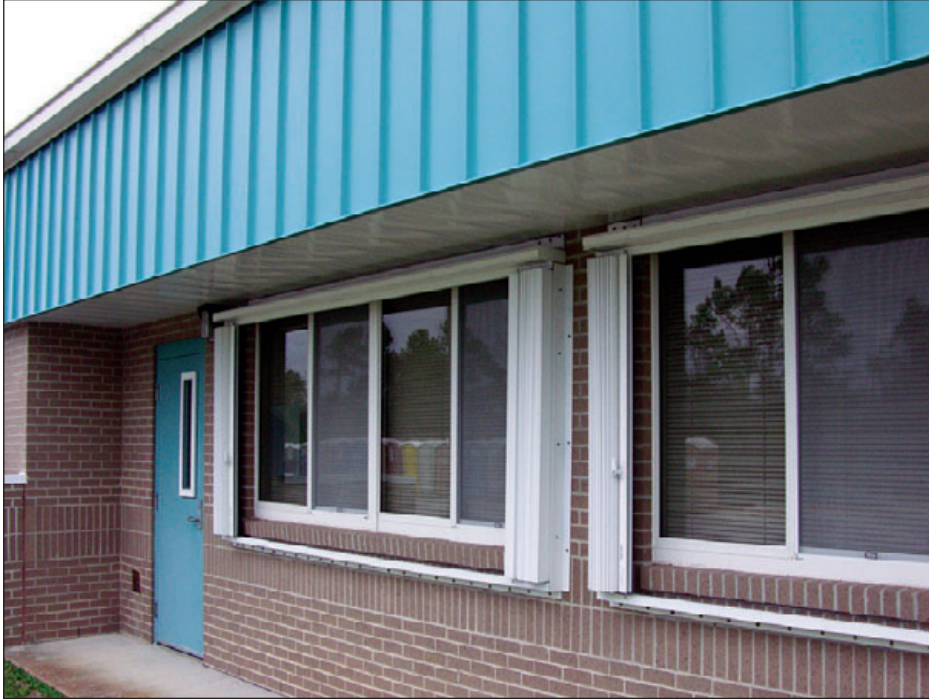
Figure 6-125:
This school has
accordion shutters.
Estimated wind
speed: 105–115 mph.
Hurricane Ivan (Florida,
2004)
